EVALUATION OF 30 KW AND 2.5 KW  
GENERATORS USED ON SERVPAC  
ARS AND ATF CLASS SHIPS

November 1974

Prepared for  
PERA(CSS)  
Hunters Point Naval Shipyard  
San Francisco, Calif.

Publication 1620-01-2-1338

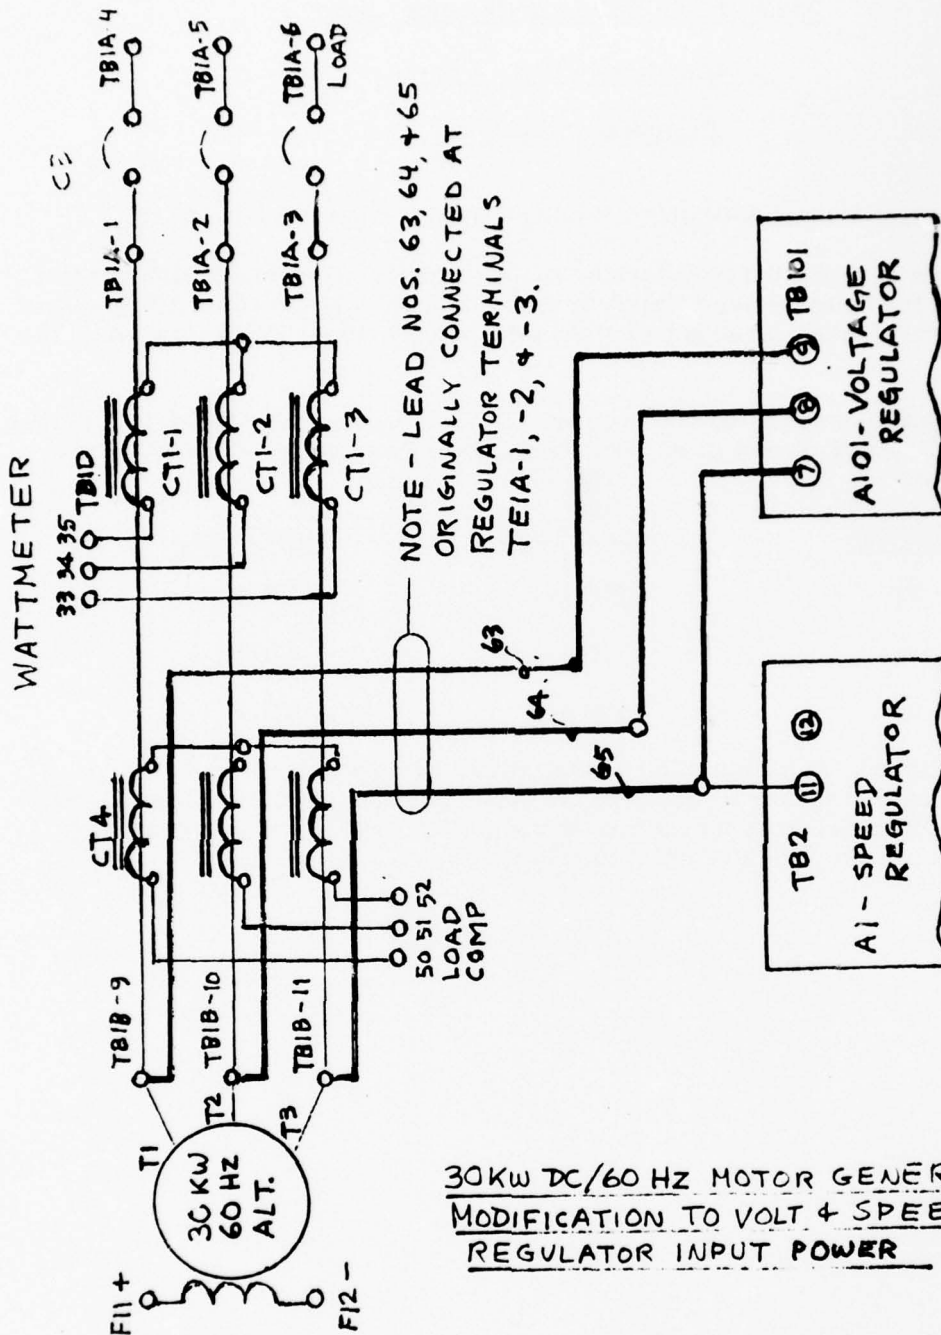
30 KW DC/60 HZ MOTOR GENERATOR SET  
MODIFICATION TO VOLT & SPEED  
REGULATOR INPUT POWER

3. The attached sketch reflects the circuit modification which connects the regulator potential transformer leads to the generator side of current transformer (CT4). This action prevents the current transformers from supplying generator field excitation when a regulator short circuit develops.

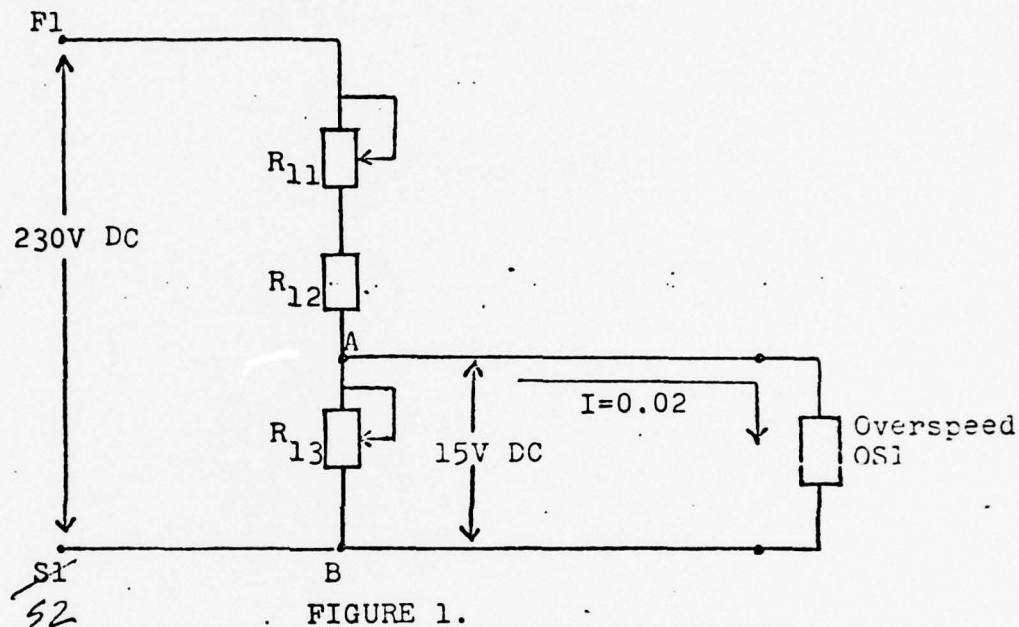
FIGURE 1.

These resistors have incorrect value and power rating.

$$\begin{aligned}
 V_{F1-S1} &= 230V \text{ DC} \\
 R_{12} &= 160W, 75 \text{ ohms fixed} \\
 R_{13} &= 25W, 10 \text{ ohms adjustable} \\
 R_{11} &= 160W, 75 \text{ ohms variable} \\
 V_{AB} &= 15V \text{ DC} \\
 I_{OS1} &= 0.02 \text{ amps (measured)}
 \end{aligned}$$

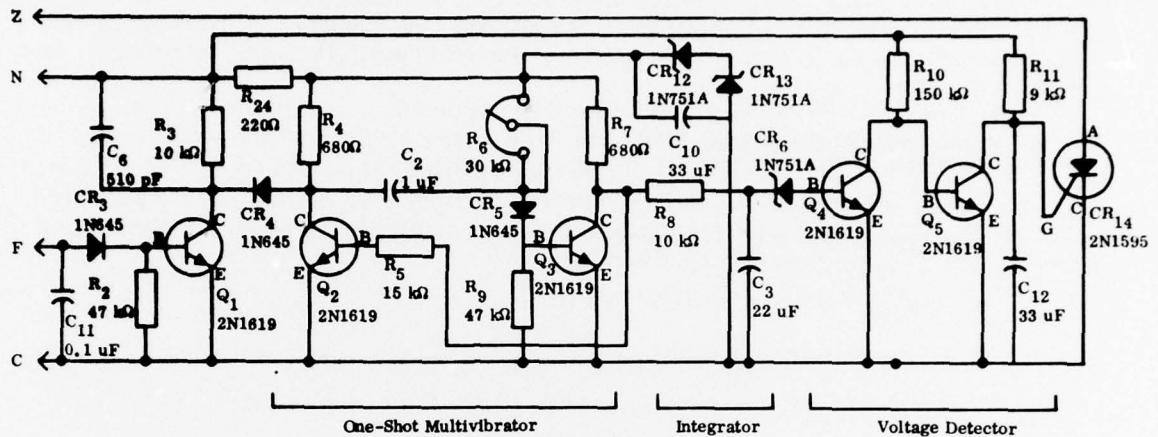
Figure C-1. Overspeed Circuit of 30 kW Motor Generator Set\*

USS CREE reported premature activation of the overspeed circuit in June 1973. Ship personnel felt that the condition was heat related, and installed ventilation to cool the area of the control panel. No similar problems have since been reported. The failed overspeed circuit board was analyzed in detail by ARINC Research. The analysis (described in Appendix C) revealed that the overspeed threshold setting is a function of circuit component parameters sensitive to temperature changes. As temperature increases the threshold setting decreases, for example from 33 to 28 Hz when the temperature rises from 25° to 50°C. Since the nominal frequency of the overspeed circuit is 30 Hz, the temperature change would cause the circuit to sense an overspeed condition and trip off the MG set.

The overspeed circuit board from the MG set identified by Technical Manual NAVSHIPS 0962-046-0010 was analyzed in detail. The circuit schematic is shown in Figure C-1.

With the addition of control panel ventilation, this problem never recurred on CREE; however, the circuit deficiency remains. ARINC Research recommends that a circuit modification be made to all like equipments (overspeed board 3050049) operated in areas exposed to high ambient temperatures. The modification would encompass the following:

- a. Replace R10 (150 k $\Omega$ ) with a 1 k $\Omega$  metal film resistor RC20GF102K.

- b. Replace R6 (potentiometer) with either RT12C2L203, RT11C2L203, or PT22C2L203.
- c. Replace C2 with a metalized polycarbonate type (there are no Mil-qualified parts). Recommended is TRW type X463UW, 1 uF, 50V, 0.312-inch diameter, 11/16-inch length (not a one-to-one fit; a circuit board modification would be necessary).
- d. Set the overspeed threshold to 15% above nominal (i.e., to ~34.5 Hz).

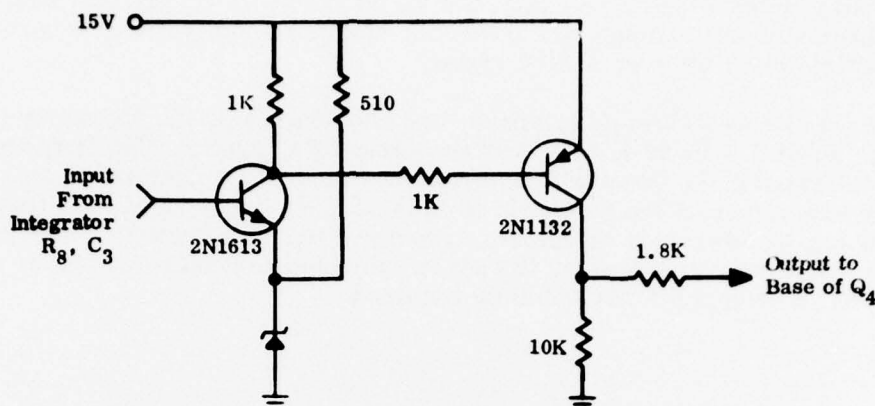
Figure C-2. Recommended Modification to Voltage Detector

The above analytical results were observed in the laboratory. The output of the integrator (R<sub>8</sub> and C<sub>3</sub>) was measured at the point of turnon of the voltage level detector and subsequent firing of the SCR. This level was 2.25 volts. This value for triggering indicates that the 5.1 volt zener diode (CR<sub>6</sub>) is operating below the knee of its characteristic, and therefore the zener effect is not being utilized to achieve an abrupt turnon of transistor Q<sub>4</sub> at the required voltage level. This effect is due to the present circuit design – abrupt voltage detection cannot be achieved in the present configuration. A simple modification, such as shown in Figure C-2, may be used to provide a stable voltage detector and thus avoid all of the above problems. The modification illustrated in Figure C-2 would require circuit board changes and therefore may not be easy to implement. An alternative modification – simpler, but not quite

To increase the base drive needed to saturate Q<sub>5</sub>, and to bias the zener to operate at a current level close to its knee, it is recommended that R<sub>10</sub> (150 kΩ) be replaced with a resistor of lower value, say 1 kΩ.

as effective – would be to substitute a 1 k $\Omega$  resistor for the present 150 k $\Omega$  resistor at R<sub>10</sub>, as described previously. The alternative modification would not provide as stable a circuit as the initially suggested one, but would reduce the reference problem.
